SECTION 8. MATERIEL STATE OF THE SHIP

DEFECTS

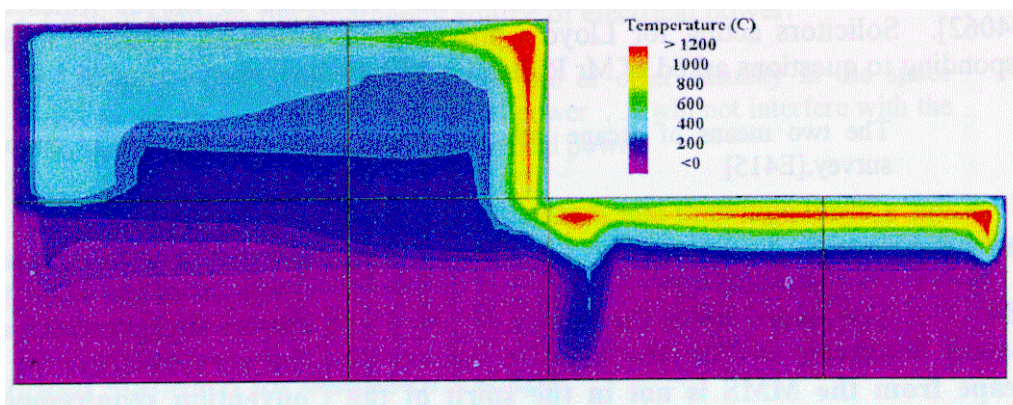
8.85 The construction of the ship above the main engines makes it highly likely that, with a large engine fire, flame will impinge on the MCR deck. Evidence given to the Board details the flame and heat hitting the deck of the MCR rolled outwards and rendered the forward escape ladder from the bottom plates to the switch room unusable almost immediately [T1857, 1858].

8.86 The fire modelling analysis that was carried out indicates the temperatures that could be expected around these ladder areas. Figure 8 indicates that one minute after the fire started, the calculated temperature near the forward escape ladder was in excess of 1200°C.

Figure 8. The predicted temperature distribution of the fire incident after 1 minute. The figure shows an aft to forward section through the origin of the fire. The bottom of the picture corresponds to the top of the starboard engine. (Fig 11 of DSTO report)

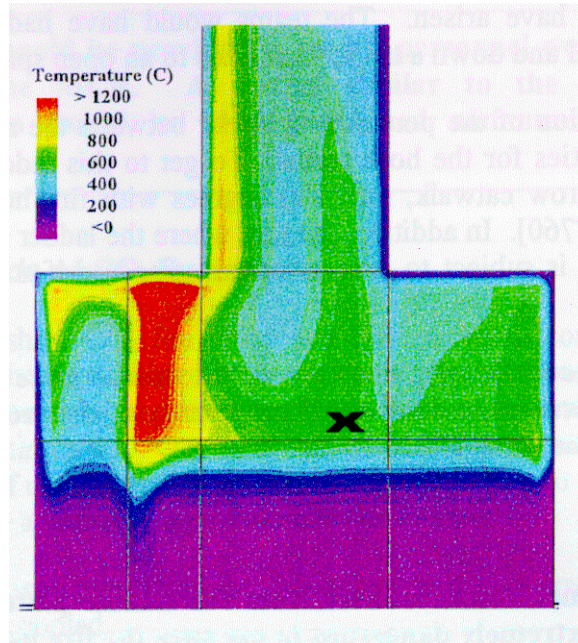
8.88 Personnel evacuating the MMS had to proceed from the middle plates to the top plates via the port or starboard central ladder. However the starboard ladder was near where the fire was hitting the bulkhead and was engulfed in flame [T1807]. The flames and heat also rolled aft from under the MCR deck near the port ladder and made egress extremely hazardous.[T1244] Figure 9 indicates the calculated temperature around the top of the port ladder.

Figure 9. Temperatures distribution 1 minute into the event for a cut across the compartment aft of the MCR looking aft. High temperatures of the order of 400°C are predicted to exist at the top of the port ladder (marked with an X). (Fig 12 DSTO report)
