Report of the  
Board of Inquiry  
into the fire in  
HMAS WESTRALIA  
on 5 May 1998

EXECUTIVE SUMMARY

## REPORT OF FIRE IN HMAS WESTRALIA ON 5 MAY 1998

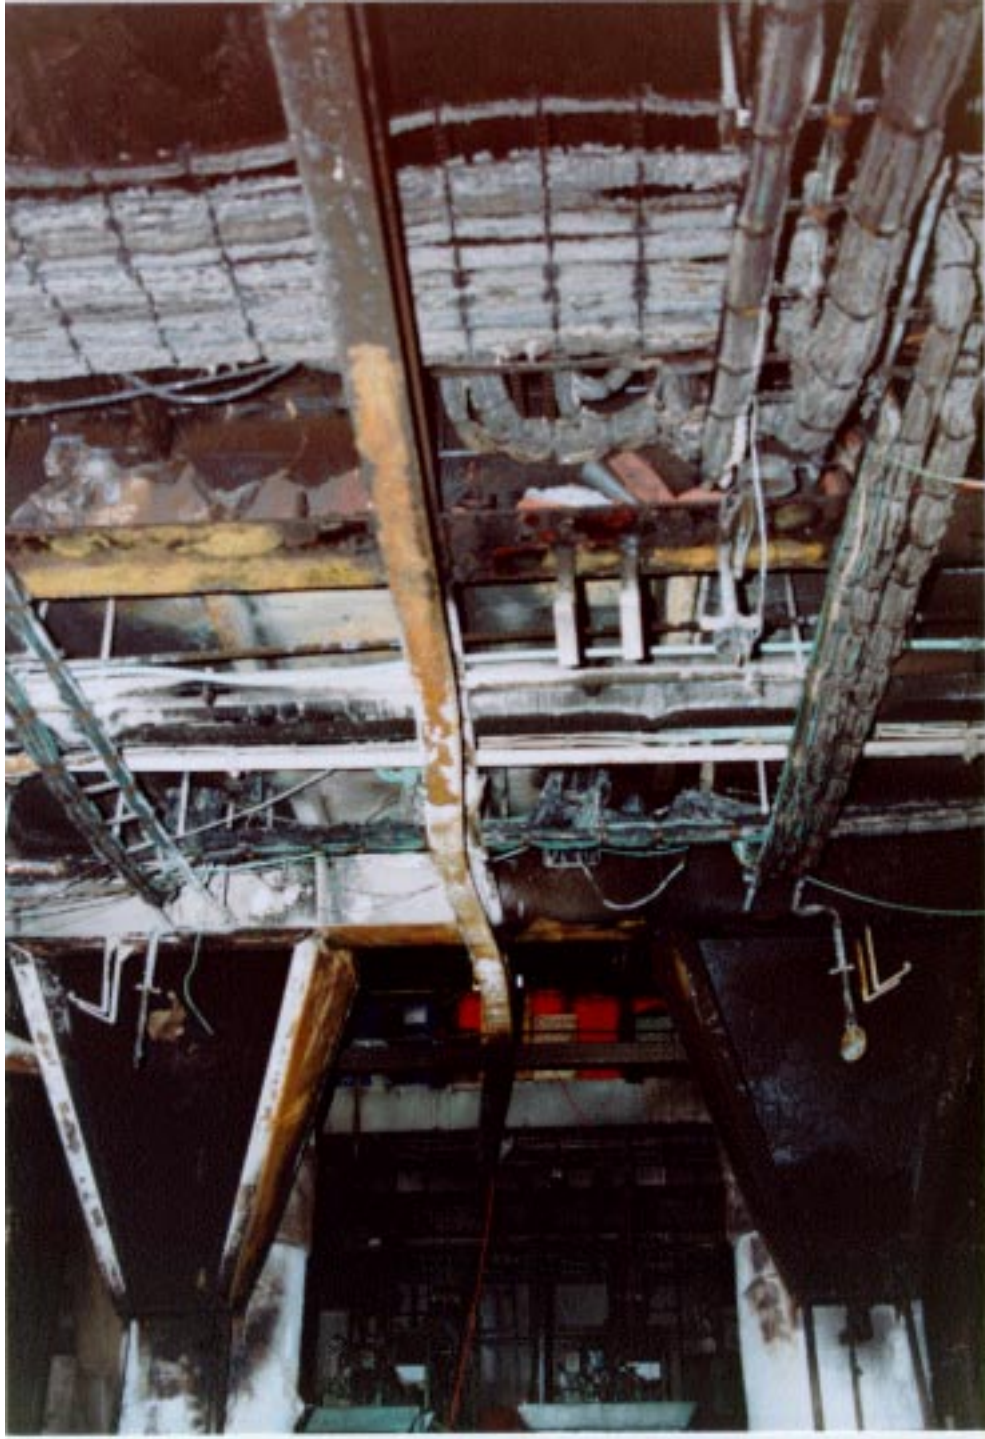
13. The fire was intense, causing rapid smoke build up and extreme heat. Despite some heroic but unsuccessful firefighting efforts, the atmosphere in the main machinery space soon became inadequate to support life. Electrical cabling on the deckhead over the fire was quickly damaged (Figure 1) with a consequent loss of services, including some communications.

Figure 1. Fire damaged cabling above the main engines (underneath the machinery control room) Photograph courtesy of WA Police Service

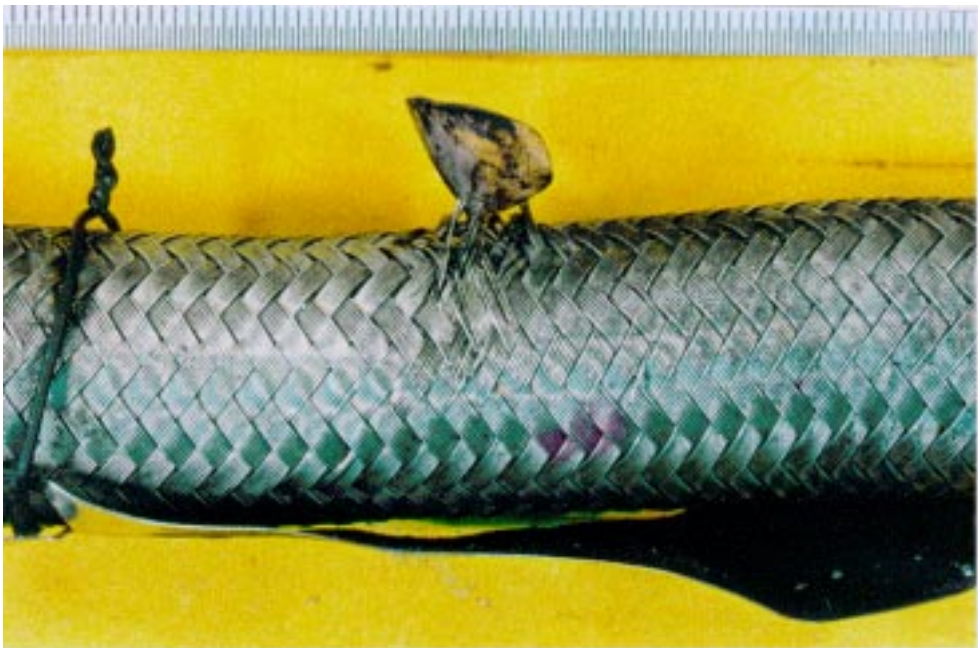
58. The fire was caused by fuel spraying under pressure from a hole in a newly fitted flexible fuel hose (Figure 2) on the starboard main engine coming into contact with a hot machinery component. A contributing factor to the size of the fire was probably fuel that spilt some minutes earlier from a similar leak from a hose on the port main engine. The supply of fuel to the fire was reduced by the prompt shut down of the starboard engine; the isolation of electrical power to the fuel boost pump and the operation of the remote fuel shut off valves. There is a possibility that fuel draining from the return line fed the fire for some time, albeit at a much reduced rate.

Figure 2. Hose S9R. The inner teflon tube can be seen protruding through the wire braid in a fan shape. Figure 48 from Metlabs Report

59. Testing of the failed and other fuel hoses clearly demonstrated that the steel braiding wires had failed due to fatigue after less than 40 hours operation. The failed hoses had approximately 50 adjacent wires in 5 to 7 braids fractured leaving the internal teflon tube unsupported.

60. What caused the flexible fuel lines to fatigue? Diesel engines with jerk pumps are known to be prone to pressure pulses in the fuel system. The most likely source of the fatigue loading was the action of the injector pump which releases spill pressure pulses into the supply and return lines of the low pressure fuel system, with the magnitudes of high but uncertain peak value. The presence of these pulses is well known by the engine
