NOVEMBER 2010

# TOUCHDOWN

THE FLEET AIR ARM SAFETY AND INFORMATION MAGAZINE

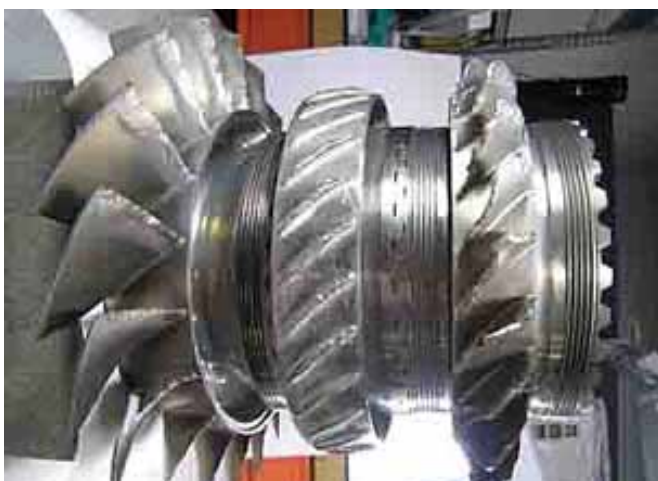
FIG 1. The remains of Destrier 11's number one engine axial compressor discs.

The engine failure of Destrier 11, as it turned out, was not an isolated incident within the NH90 world-wide fleet. An Omani aircraft flying in France had previously experienced an audible bang and fire warning in-flight, which led to an in-flight commanded engine shut-down. Investigation revealed rupture of two rotor blades from the No.2 axial compressor disc and fire damage to the upper deck from engine

fuel spillage and ignition (NHI, 2010). Fortunately the aircraft was safely recovered. The Netherlands had also experienced an engine failure; however this one was on the ground. Investigation revealed three rotor blades ruptured from the No.2 axial compressor disc (NHI, 2010). The common thread here was the model and variant of the engine in use and area of damage. Compressor damage discovered during inspection of the same engine model and variant in other countries has confirmed a serious problem and led to an extended suspension of MRH90 flying operations for the ADF.

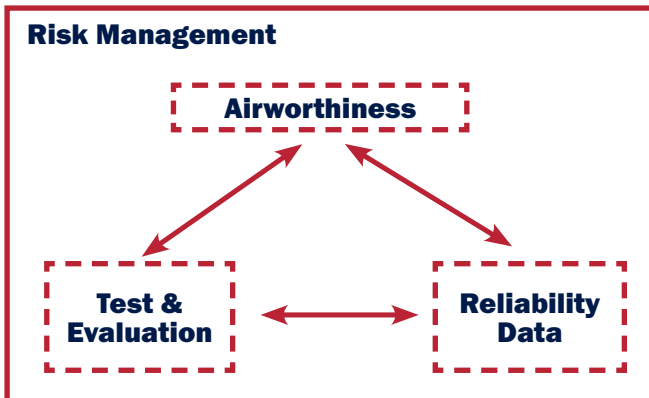
FIG 2. Holistic SMS – Functional relation between parts and the whole.

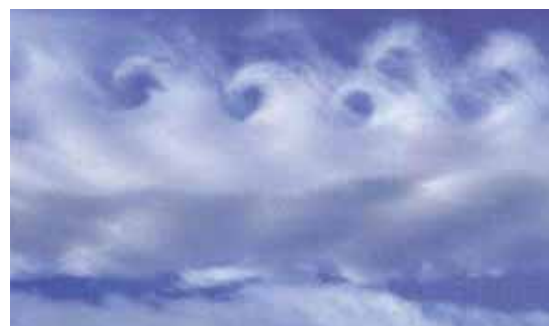
FIG 4. Kelvin-Helmholtz instabilities

**Vertical Shear** – This results when the wind strength differs vastly with altitude. This can be evident in cloud formations known as Kelvin-Helmholtz instabilities (Fig 4) but can also be evident as CAT. As a general rule throughout Australia, severe turbulence will be forecast due to vertical shear when the wind speed changes by more than 10kts over a 1000ft deviation in altitude.
